# Manhole Inspection Summary

Manhole # S33M1\_009MH

Insp Date: **3/24/08 1:08 PM**

**Location** Address: **201 Seamon Ave.**

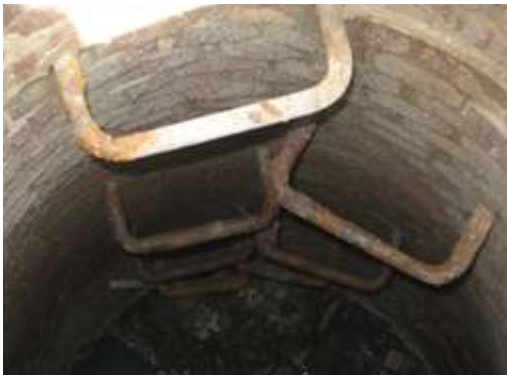
Steps

Count: **7** Missing: **0** ☒ **Corroded**

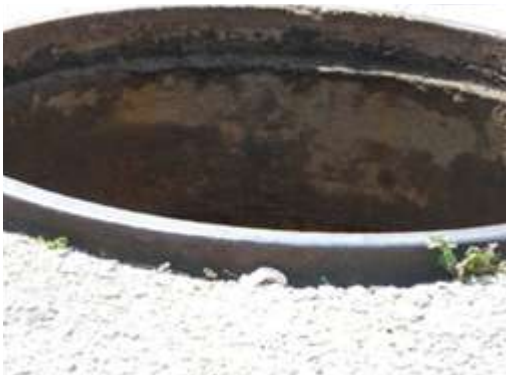
Defect 3

Above Ground

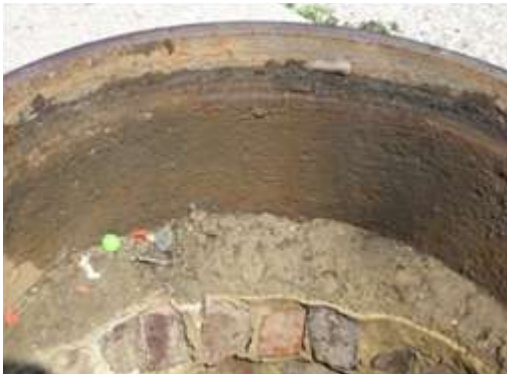
Defect 1

Offset: **3.5** (in.)

Frame Offset

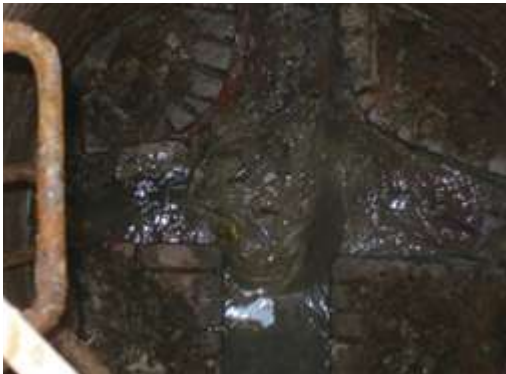
Defect 2

Condition: ☐ Sound ☐ Cracked ☐ Root Intrusion ☐ Deteriorated ☐ Leaks ☒ **Debris**

Debris/ Partial Blockage

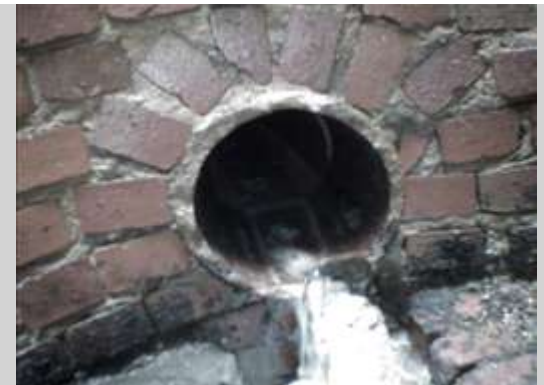
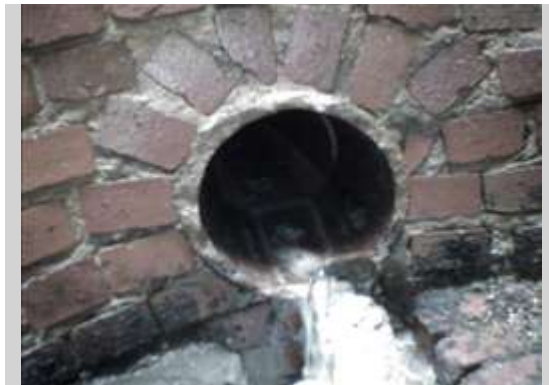
3 O'Clock Inflow  
Pipe In @ 3 O'Clock

Pipe Height: **8.4** (in.) Rod and Bar (Angled)  
Pipe Material: **Clay** ☐ Pipe Lined  
Invert Depth: **12.79** (ft.) Flow Characteristics: **Fast**  
Deposits: ☒ None ☐ Mud ☐ Sludge ☐ Debris ☐ Grease  
Silt Depth: (in.) Deposits Extent:  
Infiltration: **None** Pipe Seal Cond: **Cracked**

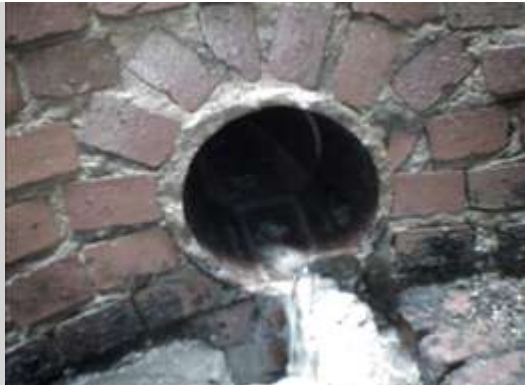
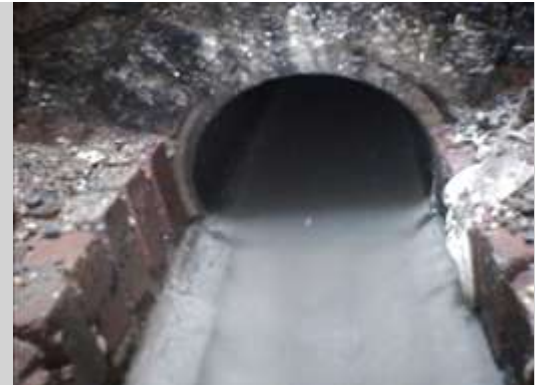
6 O'Clock Inflow

Deposits: ☒ None ☐ Mud ☐ Sludge ☐ **Debris** ☐ Grease

Silt Depth: **2** (in.) Deposits Extent: **Light**

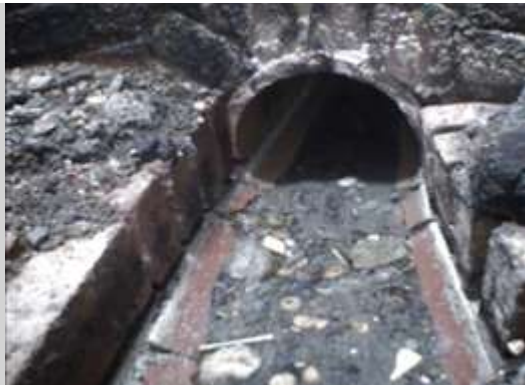
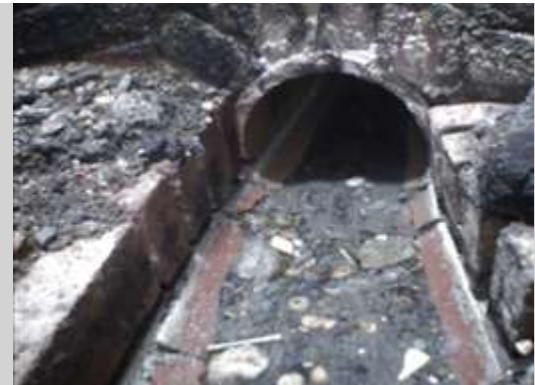
9 O'Clock Inflow

Deposits: ☐ None ☐ Mud ☐ Sludge ☒ **Debris** ☐ Grease

Silt Depth: **2** (in.) Deposits Extent: **Medium**
